CLINICAL INFORMATION

A unique case of pulmonary artery catheter bleeding from the oximetry connection port

Suman Rajagopalan*, Raja R. Palvadi

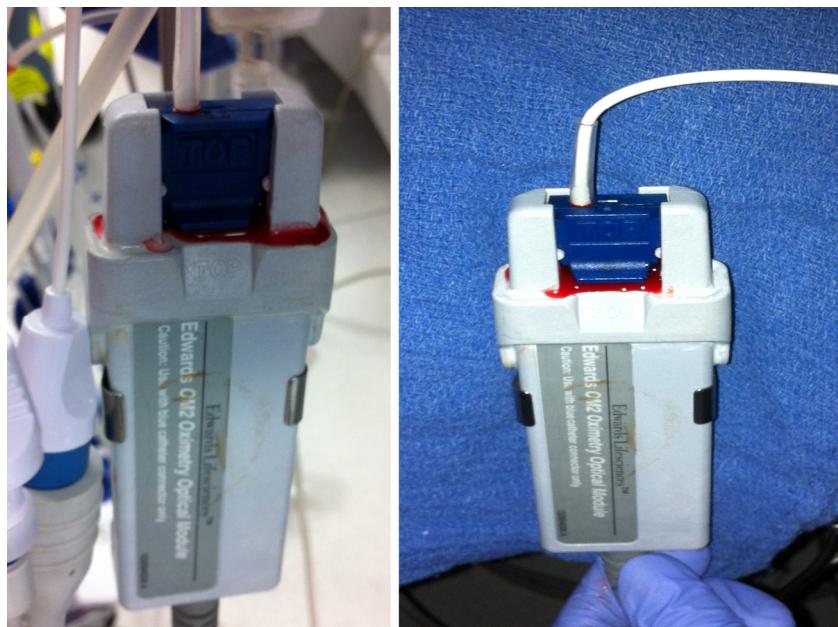
Figure 1 Persistent oozing of blood from the oximetry optical module connection port of the PAC.

A 57-year-old male with aortic coarctation and pseudoaneurysm of the descending thoracic aorta was scheduled for surgical repair. After successful induction, a 9Fr introducer was inserted into the right internal jugular vein by modified Seldinger's technique using ultrasound guidance. A PAC (model number 746HF8) was placed through the introducer. Appropriate waveforms and monitoring of the mixed venous saturation were successful. However, when continuous cardiac output monitoring was attempted, an erroneous message was displayed. While attempting to troubleshoot the error, persistent oozing of blood from the oximetry optical module connection site was noted (Fig. 1). Due to the bleeding from the connection site and inability to record cardiac output, the defective catheter was removed and a new catheter was placed through the existing introducer sheath. The defective catheter was visually inspected and no obvious external defects or tears were detected. The catheter was sent back to the manufacturer (Edward Lifesciences) to evaluate the cause of bleeding. The surgery progressed as planned and the patient was transferred to the ICU for further post-operative management. A couple of weeks later, we received the report from the manufacturer confirming the presence of a small tear in the webbing of the catheter (78 cm from the tip) that was due to a manufacturing defect.

In conclusion, the reported case here is an unusual presentation of the manufacturing defect of the pulmonary artery catheter. The defect was not visible to the naked eye or to the routine pre-insertion testing of the PAC but became evident after its placement. Abnormal oozing from the connection port of the PAC indicates a damaged catheter and rather than going through the frustration of troubleshooting the catheter, it is advisable to replace the catheter which may be the most efficient and right thing to do in this situation.
