Assessment of the hospital emergency environment: a study in light of the ergonomic methodology for the built environment (meac)

Given the need to adapt spaces to users and tasks, this study aims to carry out an ergonomic assessment of the adult urgency and emergency unit of a University Hospital (HU) in the city of Florianópolis (SC), through the application of the Ergonomic Methodology for the Built Environment (MEAC) (VILLAROUCO, 2009).

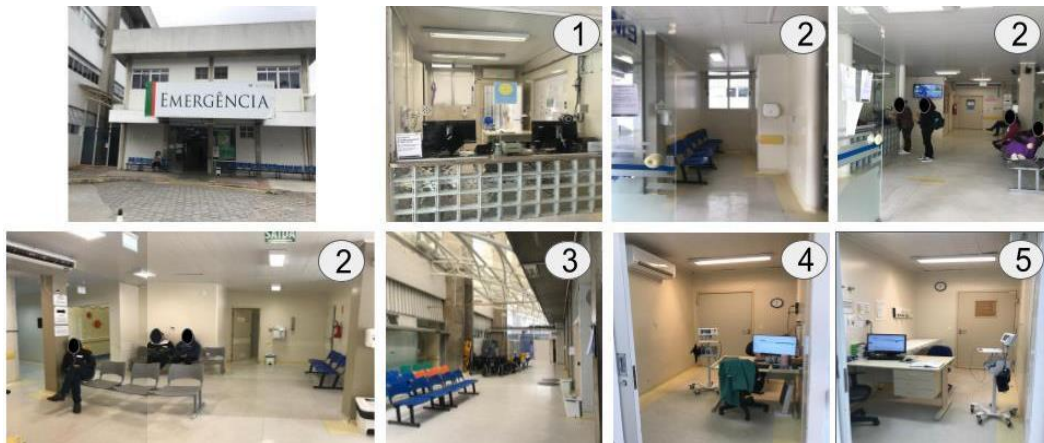
Figure 2 - Photos of study environments.

The emergency area is divided into reception and service, waiting room 1 and 2 and triage 1 and 2, as shown in Table 1 and Figure 2. The service room also receives the pediatric emergency, which was not explored in the present study.

Surface materials are similar in the environments studied. The flooring is light gray vinyl blanket for heavy traffic. The walls are mostly painted with beige semi-gloss acrylic paint, with 2 walls in exposed concrete and white ceramic tiles found in Espera. In Wait 1 it is possible to find PVC stretcher profiles in yellow. Between Waiting 1 and Service there is a half wall of glass blocks and a glass panel with speakers for communication. The lining is made of PVC sheets with a smooth white outer surface. Espera 2 does not have a lining and the roof is made of translucent acrylic with a metal structure.

Regarding the furniture, long polypropylene chairs were identified in gray, black, navy blue, green and orange; black nylon wheelchairs; square and rectangular overhead lamps with LED lamps that vary between neutral and cold colors. The Service, Waiting 1 and both screening areas are air-conditioned with split air conditioning. According to ABNT NBR 9050:2020, there is disagreement with some of the established criteria. There is no tactile warning and directional flooring, the service counter does not have a lowered area for people of short stature or wheelchair users, and there is no sound signaling for service. The positive points are a waiting area dedicated to wheelchair users and obese people, doors with sufficient width, automatic doors or doors with adequate weight to handle people with paresis. Signage and escape routes are as expected and fire extinguishers are well distributed.
